**FIRE ENGINEERING RESEARCH LABORATORY**  
IIT Gandhinagar, Palaj, Gandhinagar, Gujarat - 382 055

**Test Report**

(Document No.: FERL/TR/01/I3/U0)

| <b>Type of Sample</b> | | Fire Rated Hinged Door (Wooden Composite) | |

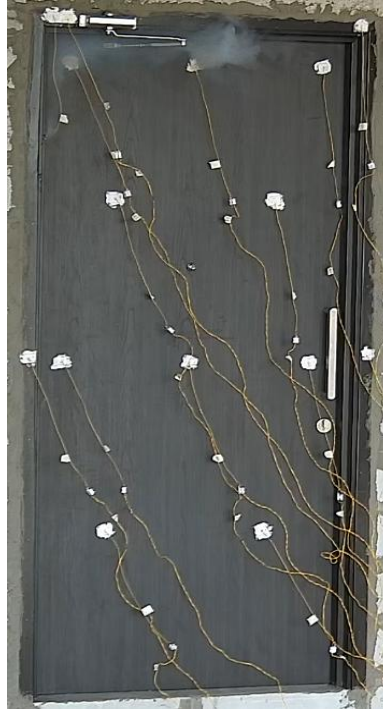
b) t= 01 min, grey smoke was observed emanating from the top edge of the leaf.

| Time<br>(Hr:min) | Observations |
|---|---|
| 00:01 | Grey smoke was observed emanating from the top edge of the leaf. |

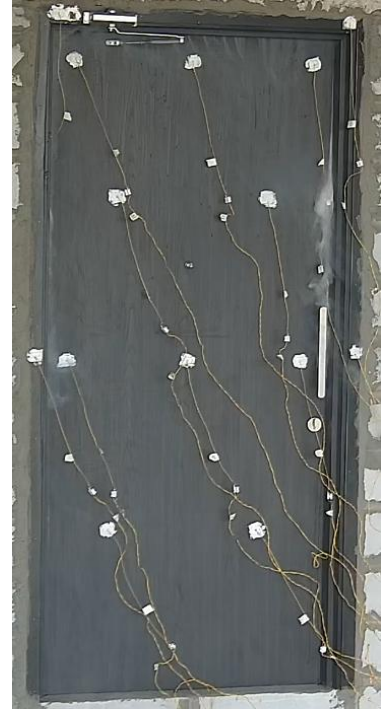
c) t= 15 min, heavy grey smoke emission was observed from the edges of the leaf.

| Time<br>(Hr:min) | Observations |
|---|---|
| 00:15 | Heavy grey smoke emission was observed from the edges of the leaf. |

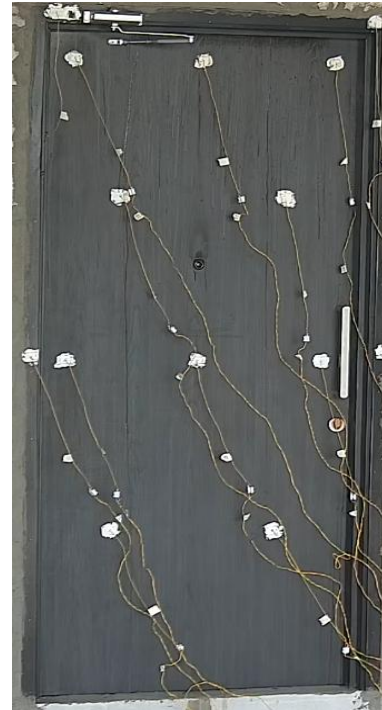
f) t= 60 min, oil leakage was observed from the door closer.

| Time<br>(Hr:min) | Observations |
|---|---|
| 01:00 | Oil leakage was observed from the door closer. |

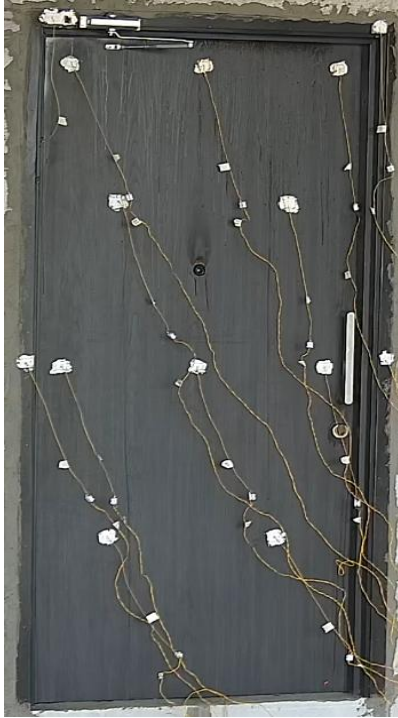
g)  $t = 75$  min, blackening was observed near the door viewer.

| Time<br>(Hr:min) | Observations |
|---|---|
| 01:15 | Blackening was observed near the door viewer. |

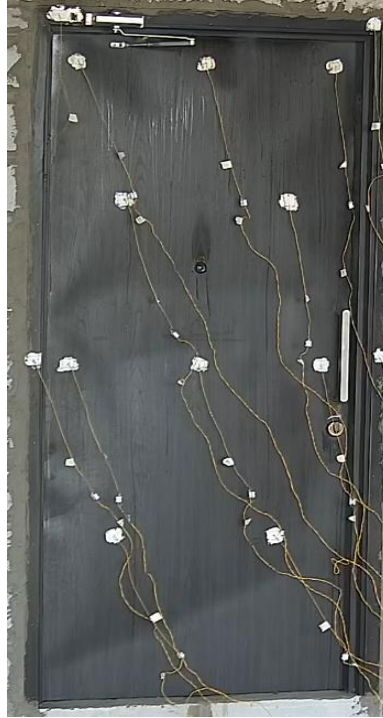
h)  $t = 90$  min, formation of a bubble was noted on the door leaf.

| Time<br>(Hr:min) | Observations |
|---|---|
| 01:30 | Formation of a bubble was noted on the door leaf. |

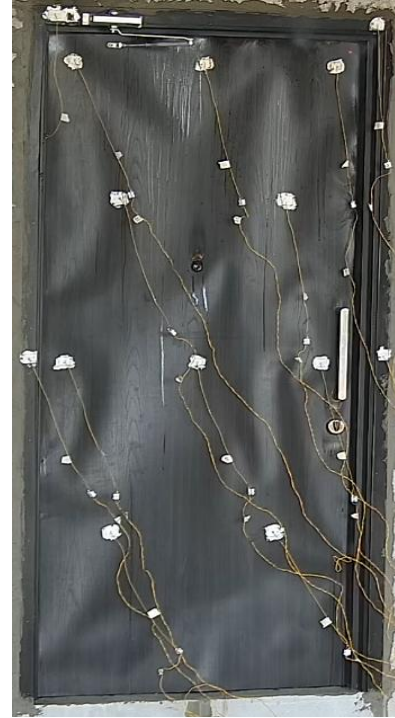
i)  $t = 105$  min, complete swelling of the outer sheet of the door leaf was noted.

| Time<br>(Hr:min) | Observations |
|---|---|
| 01:45 | Complete swelling of the outer sheet of the door leaf was noted. |

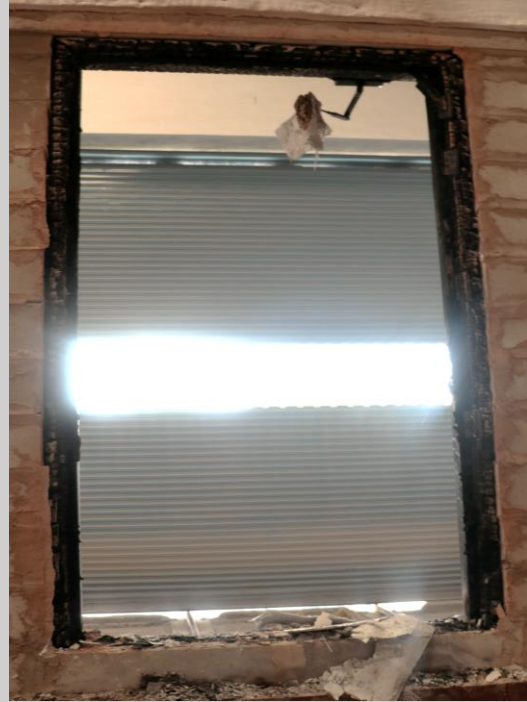
**After Test<sup>#</sup>**

<sup>#</sup>The shutter detached from the frame after the test.
