**FIRE ENGINEERING RESEARCH LABORATORY**  
IIT Gandhinagar, Palaj, Gandhinagar, Gujarat - 382 055

### Test Report

(Document No.: FERL/TR/01/I3/U0)

| <b>Type of Sample</b> | | Fire Rated Hinged Door (Wooden Composite) | |

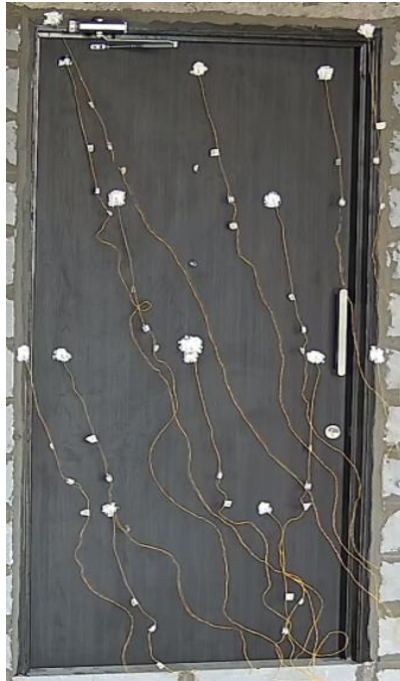
a)  $t = 0$  min, start of the test.

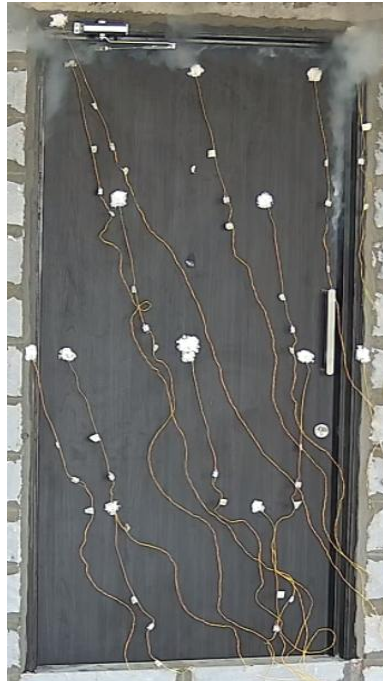
b)  $t = 05$  min, grey smoke was observed emanating from the top edge of the leaf.

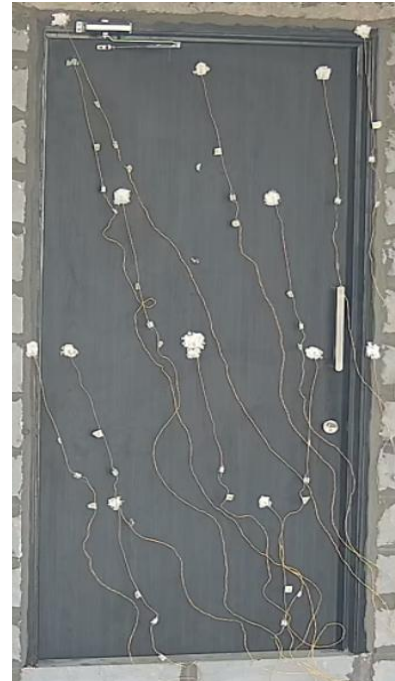
c)  $t = 15$  min, no significant change observed.

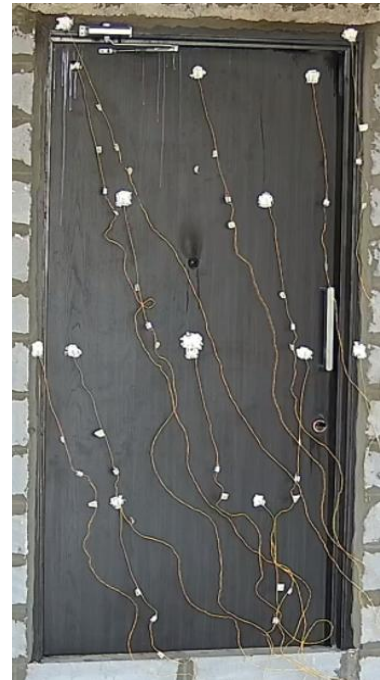
f)  $t = 60$  min, increased blackening was observed near the door viewer.

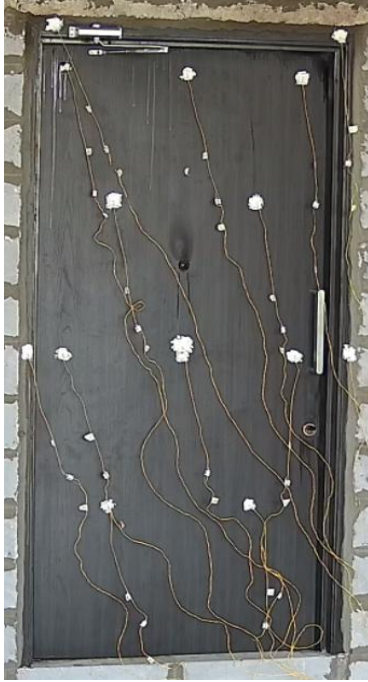
g)  $t = 65$  min, at the end of the test.
